**Flood Control Project Maintenance  
Levee Inspections**

**Maintenance Issue Types Only, Levee Inspection Report By Mile - Fall 2014**

**Reclamation District No. 0900 West Sacramento**

Waterway	Bank	Unit Miles	Inspection Start/End	Inspector
Unit No. 01 Sacramento River	Right	7.70	10/29/2014 10/29/2014	Pavel Kazi

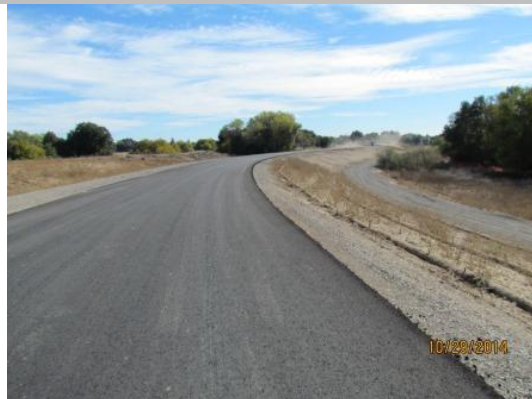
Photo 1 of 1 : FA\_2014\_RD0900\_230\_1\_20141029\_00024.jpg

LM Start	2.00	Rating **	A/W	Issue No.	1
LM End	2.27	Issue Type +	Ma	Location *	CR
Category	Earthen Levee			GPS Latitude/Longitude	
				Start	End
Item	Vegetation			38.559202 °	38.555462 °
				-121.517707 °	-121.516297 °
DWR ID	DWR_RD0900_01_s_2012_1				
Action/Comments					
Remove the wild growth other than native grasses from the levee slopes.					
Inspector Comments: USACE has started to construct a setback levee in this area and has taken control of this portion of the levee.

View of the new setback levee looking downstream during fall 2014 inspection.

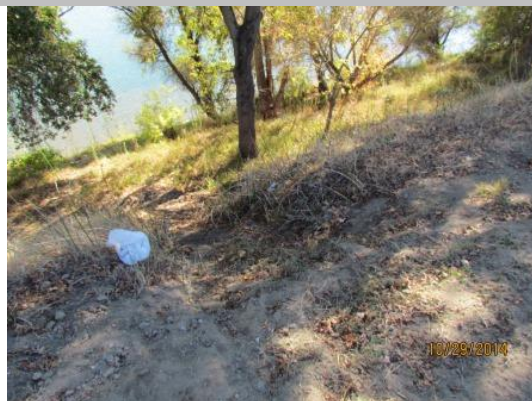
Photo 1 of 2 : FA\_2014\_RD0900\_230\_4\_20141029\_00025.jpg

Updated picture of the slope instability on the waterside of the levee during fall 2014 inspection

LM Start	3.42	Rating **	M	Issue No.	4
LM End	3.42	Issue Type +	Ma	Location *	WS
Category	Earthen Levee			GPS Latitude/Longitude	
				Start	End
Item	Slope Stability			38.539770 °	38.539770 °
				-121.515276 °	-121.515276 °
DWR ID	DWR_RD0900_01_s_2014_4				
Action/Comments					
Repair the levee slope damaged by foot traffic and prevent access where possible.

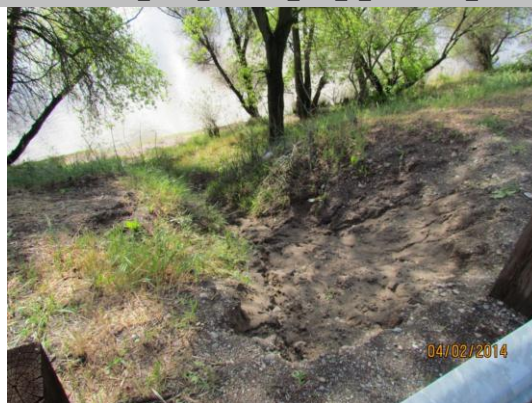
Photo 2 of 2 : FA\_2014\_RD0900\_230\_4\_20141021\_00003.jpg

A slope instability was found on the waterside slope of the levee looking downstream.

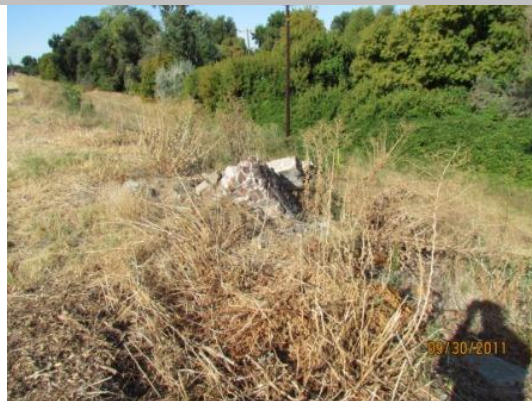
Photo 1 of 1 : FA\_2014\_RD0900\_230\_327\_20141021\_00018.jpg

LM Start	4.05	Rating **	M	Issue No.	327
LM End	4.05	Issue Type +	Ma	Location *	LS
Category	Earthen Levee			GPS Latitude/Longitude	
				Start	End
Item	Encroachments			38.534759 °	38.534759 °
				-121.524902 °	-121.524902 °
DWR ID	DWR_RD0900_01_s_2012_327				
Action/Comments					
Debris

Concrete debris were found on the landside of the levee looking upstream.

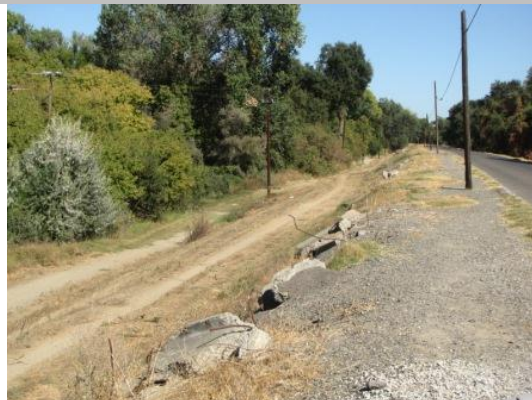
Photo 1 of 1 : FA\_2014\_RD0900\_230\_54\_20141021\_00014.jpg

LM Start	4.11	Rating **	M	Issue No.	54
LM End	4.11	Issue Type +	Ma	Location *	LS
Category	Earthen Levee			GPS Latitude/Longitude	
				Start	End
Item	Encroachments			38.534364 °	38.534364 °
				-121.526051 °	-121.526051 °
DWR ID	DWR_RD0900_01_s_2012_54				
Action/Comments					
Debris					
Inspector Comments: Concrete debris with metal posing a safety risk.

View of concrete debris with metal looking upstream.

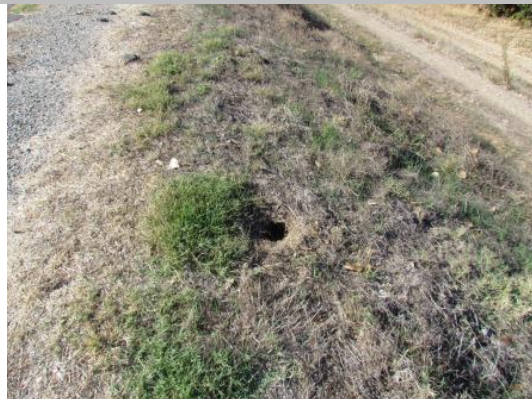
Photo 1 of 1 : FA\_2014\_RD0900\_230\_14\_20141021\_00008.jpg

LM Start	4.12	Rating **	M	Issue No.	14
LM End	4.12	Issue Type +	Ma	Location *	LS
Category	Earthen Levee			GPS Latitude/Longitude	
				Start	End
Item	Animal Control			38.534345 °	38.534345 °
				-121.525966 °	-121.525966 °
DWR ID	DWR_RD0900_01_f_2013_14				
Action/Comments					
No rodents visible, but rodent burrows visible; need to backfill and compact or grout burrows.

An animal hole was found on the landside shoulder of the levee looking downstream.

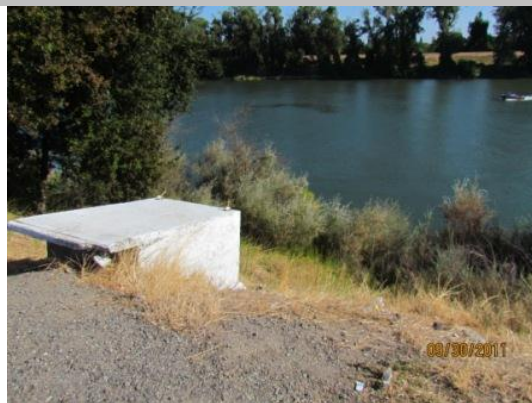
Photo 1 of 1 : FA\_2014\_RD0900\_230\_330\_20141021\_00019.jpg

LM Start	4.97	Rating **	M	Issue No.	330
LM End	4.97	Issue Type +	Ma	Location *	WS
Category	Earthen Levee			GPS Latitude/Longitude	
				Start	End
Item	Encroachments			38.524898 °	38.524898 °
				-121.529674 °	-121.529674 °
DWR ID	DWR_RD0900_01_s_2012_330				
Action/Comments					
Debris

Concrete anchor was found on the waterside slope of the levee looking upstream.

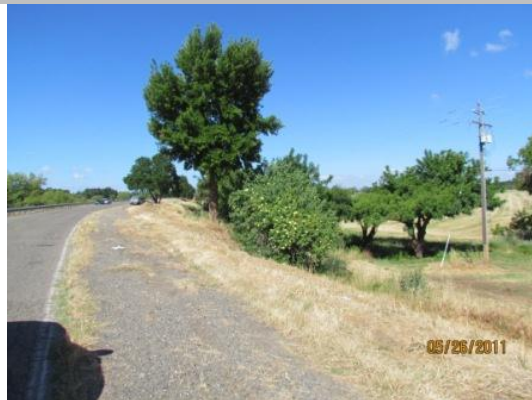
Photo 1 of 1 : FA\_2014\_RD0900\_230\_958\_20141021\_00023.jpg

LM Start	5.53	Rating **	A/W	Issue No.	958
LM End	5.53	Issue Type +	Ma	Location *	LS
Category	Earthen Levee			GPS Latitude/Longitude	
				Start	End
Item	Vegetation			38.518988 °	38.518988 °
				-121.527738 °	-121.527738 °
DWR ID	DWR_RD0900_01_s_2012_958				
Action/Comments					
Elderberries are blocking visibility and flood fight capability.

Elderberry on the landside of the levee. The picture was taken from the crown looking downstream.

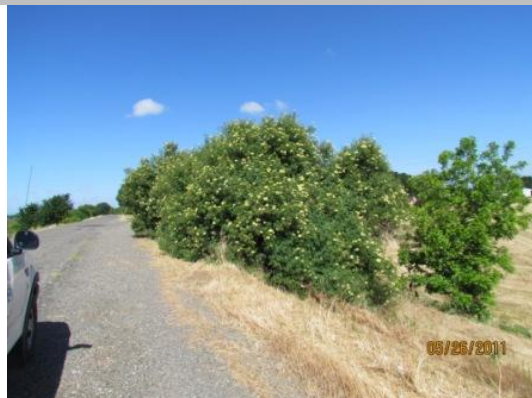
Photo 1 of 1 : FA\_2014\_RD0900\_230\_25\_20141021\_00011.jpg

LM Start	5.97	Rating **	M	Issue No.	25
LM End	5.98	Issue Type +	Ma	Location *	LS
Category	Earthen Levee			GPS Latitude/Longitude	
				Start	End
Item	Vegetation			38.517952 °	38.517948 °
				-121.535672 °	-121.535857 °
DWR ID	DWR_RD0900_01_s_2012_25				
Action/Comments					
Elderberries are blocking visibility and flood fight capability.

Elderberry located on the landside of the levee obstructing the view. The picture was taken from the crown looking downstream.

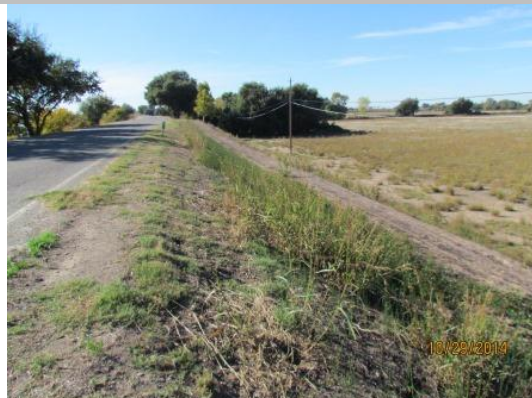
Photo 1 of 1 : FA\_2014\_RD0900\_230\_70\_20141029\_00027.jpg

View of the vegetation on the landside of the levee looking downstream.

LM Start	6.15	Rating **	M	Issue No.	70
LM End	6.83	Issue Type +	Ma	Location *	LS
Category	Earthen Levee			GPS Latitude/Longitude	
				Start	End
Item	Vegetation			38.517877 °	38.515364 °
				-121.538981 °	-121.551063 °
DWR ID	DWR_RD0900_01_f_2014_70				
Action/Comments					
Control annual grass and weeds on the levee slopes and easements.

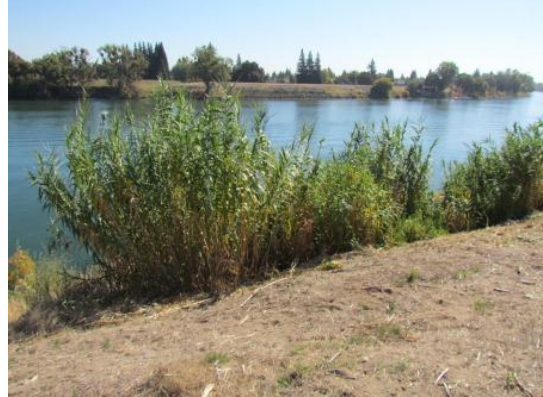
Photo 1 of 1 : FA\_2014\_RD0900\_230\_15\_20141021\_00009.jpg

LM Start	7.80	Rating **	M	Issue No.	15
LM End	7.80	Issue Type +	Ma	Location *	WS
Category	Earthen Levee			GPS Latitude/Longitude	
				Start	End
Item	Vegetation			38.503490 °	38.503490 °
				-121.559770 °	-121.559770 °
DWR ID	DWR_RD0900_01_f_2013_15				
Action/Comments					
Remove the wild growth other than native grasses from the levee slopes.					
Inspector Comments: Arrundo on the waterside

View of arundo on the waterside of the levee looking downstream.

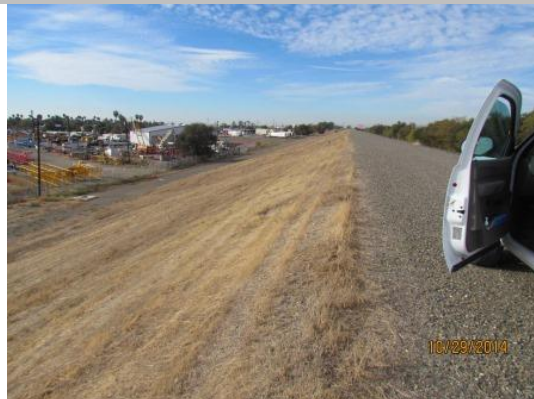
Photo 1 of 1 : FA\_2014\_RD0900\_231\_48\_20141029\_00008.jpg

View of the landside slope of the levee looking downstream.

LM Start	0.38	Rating **	A	Issue No.	48
LM End	0.38	Issue Type +	Ma	Location *	LS
Category	Earthen Levee			GPS Latitude/Longitude	
				Start	End
Item	Vegetation			38.578635 °	38.578635 °
				-121.572676 °	-121.572676 °
DWR ID	DWR_RD0900_02_f_2014_48				
Action/Comments					
Control annual grass and weeds on the levee slopes and easements.

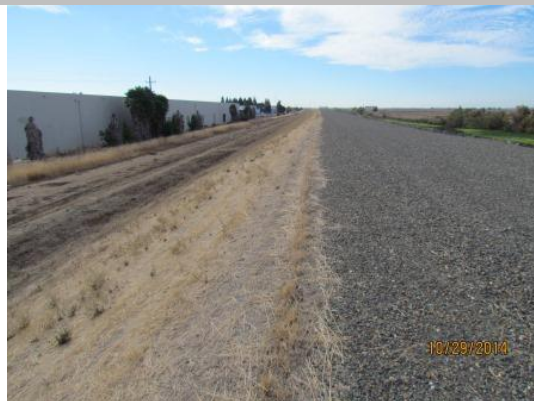
Photo 1 of 1 : FA\_2014\_RD0900\_231\_49\_20141029\_00009.jpg

View of the vegetation on the landside of the levee looking downstream during fall 2014 inspection.

LM Start	1.43	Rating **	A	Issue No.	49
LM End	1.43	Issue Type +	Ma	Location *	LS
Category	Earthen Levee			GPS Latitude/Longitude	
				Start	End
Item	Vegetation			38.567407 °	38.567407 °
				-121.582182 °	-121.582182 °
DWR ID	DWR_RD0900_02_f_2014_49				
Action/Comments					
Control annual grass and weeds on the levee slopes and easements.

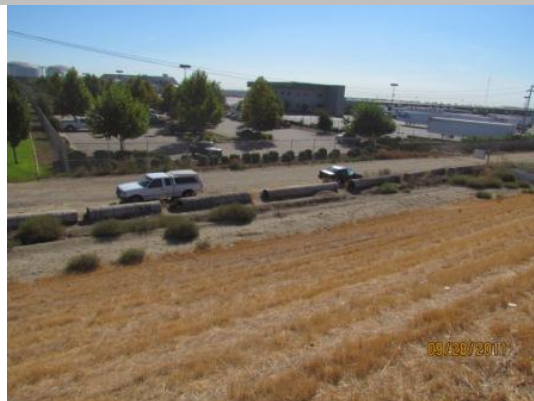
Photo 1 of 1 : FA\_2014\_RD0900\_231\_13\_20141021\_00003.jpg

LM Start	2.07	Rating **	M	Issue No.	13
LM End	2.07	Issue Type +	Ma	Location *	WS
Category	Earthen Levee			GPS Latitude/Longitude	
				Start	End
Item	Encroachments			38.558296 °	38.558296 °
				-121.582151 °	-121.582151 °
DWR ID	DWR_RD0900_02_s_2012_13				
Action/Comments					
Pipe					
Inspector Comments: HDPE pipe at the waterward toe. The LMA purposely placed the pipe to prevent people from driving up the levee.

Pipes were placed at the toe of the landside of the levee to prevent people from driving on the slope. The picture was taken from the crown looking upstream.
